SERVICE BULLETIN 03-4302

June 30, 2003

Models Affected: 39/40/43 Trawlers

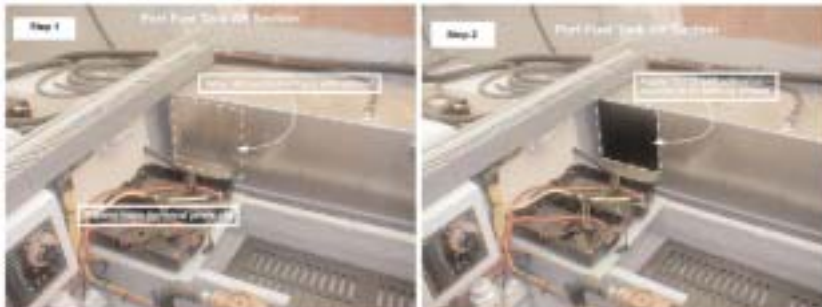
Fuel tanks may not have protective rubber pad on corner of fuel tank, near battery compartment/tray.
Contact of wrench to fuel tank, when tightening battery lugs, could cause fire hazard.

All above MUST be checked immediately to insure proper material is applied to the fuel tank as outlined in attached documentation. Attached picture is for 40 model. Pictures are available on each model if needed, all are similar. Approved labor for this function is 1 hour. Documentation of boats checked is required.

Order part number #A407340 RUBBER SHEET (1 Each)
1.88 sf • 15x15 • 1/8" self-adhesive rubber
parts@mainship.com • Fax: (912) 880-2124
